**US Army Corps  
of Engineers  
Philadelphia District**

## **Osage Avenue/Pine Street Inspections**

### **Final Report of Findings and Recommendations**

December 1997

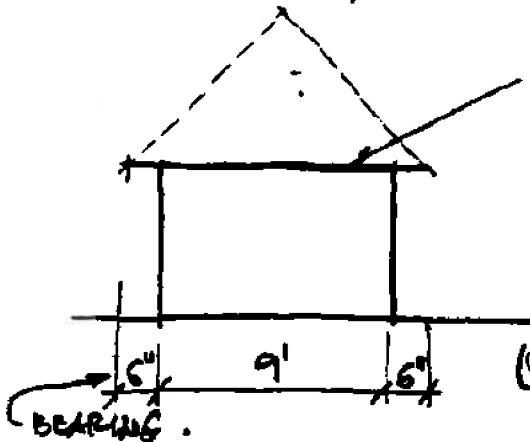
CHECK EXIST. LINTEL ABOVE GARAGE DOOR OPNNG.

3.1.9. Brick cracking and spalling is evident at the lintel terminations over the garage door openings of some of the odd numbered Osage Avenue properties. Door opening structural framing was determined to be adequate based on observed conditions in 6221 Osage upon removal of drywall and finish framing. The entire opening and framing system appears to be constructed according to code. Cracking and spalling may be attributed to initial deflection of the lintel. Calculations included in Appendix C indicate acceptable deflection. Recommended action is to replace cracked and spalled brick as per Figure 5 (Repair Item 7). No additional deflection is anticipated; therefore, this condition will not recur once repaired.

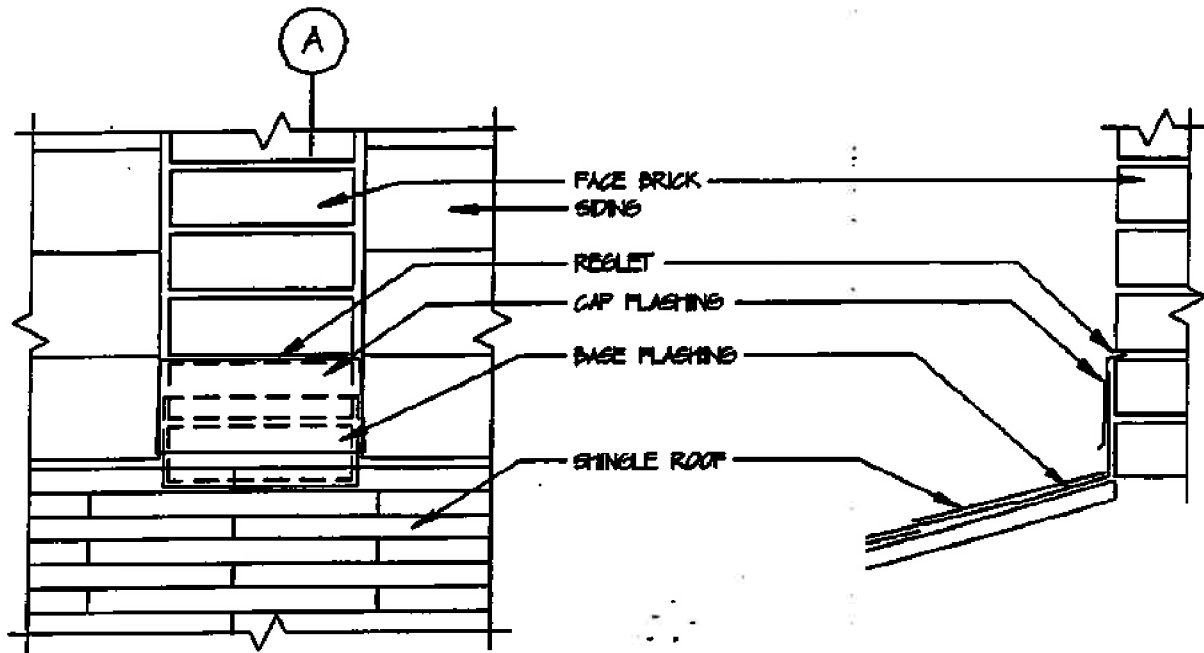
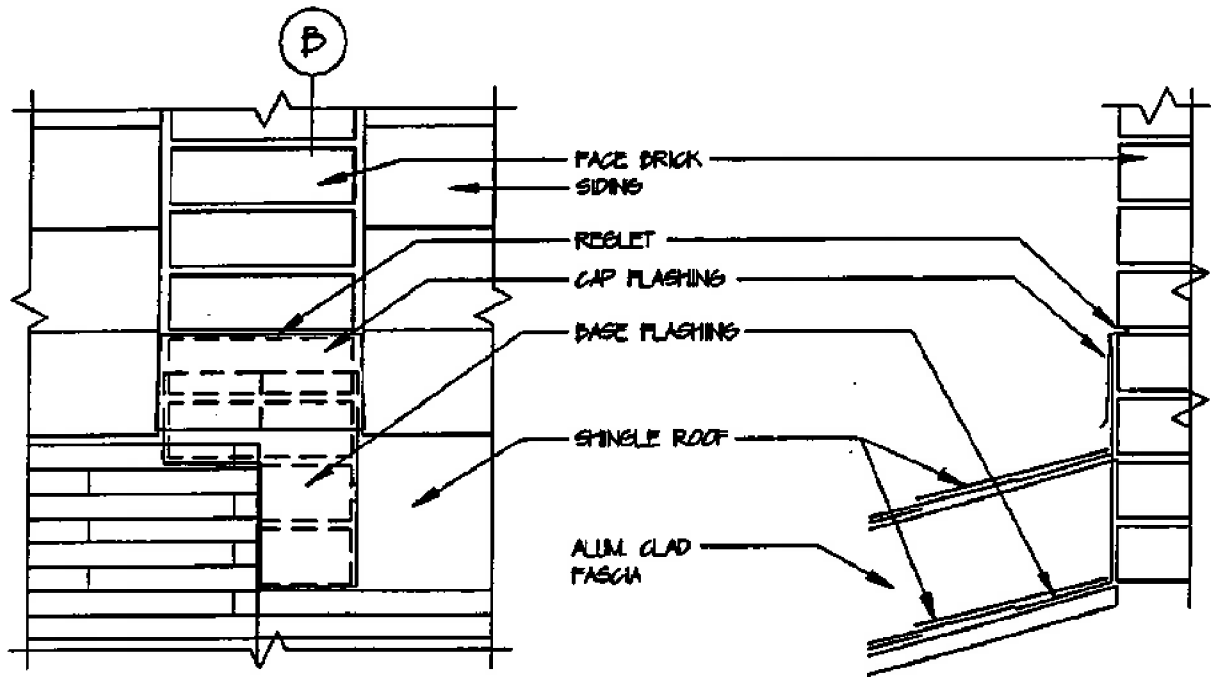
DATE	PROJECT & SHEET TITLES	DESCRIPTION	FIGURE
AUG 1957	OSAGE/PINE STREET INSPECTIONS	ROOFS ABOVE DEN	1
DESIGNED BY: S.W.	FLASHING DETAILS		
SCALE: H/2" = 1'-0"

3.1.3. The shingle roofs over the first floor den areas are improperly flashed resulting in leaks and drywall staining. Repairs to flashing are recommended for all properties (Repair Items 3). Figure 1 shows typical detail for this repair.

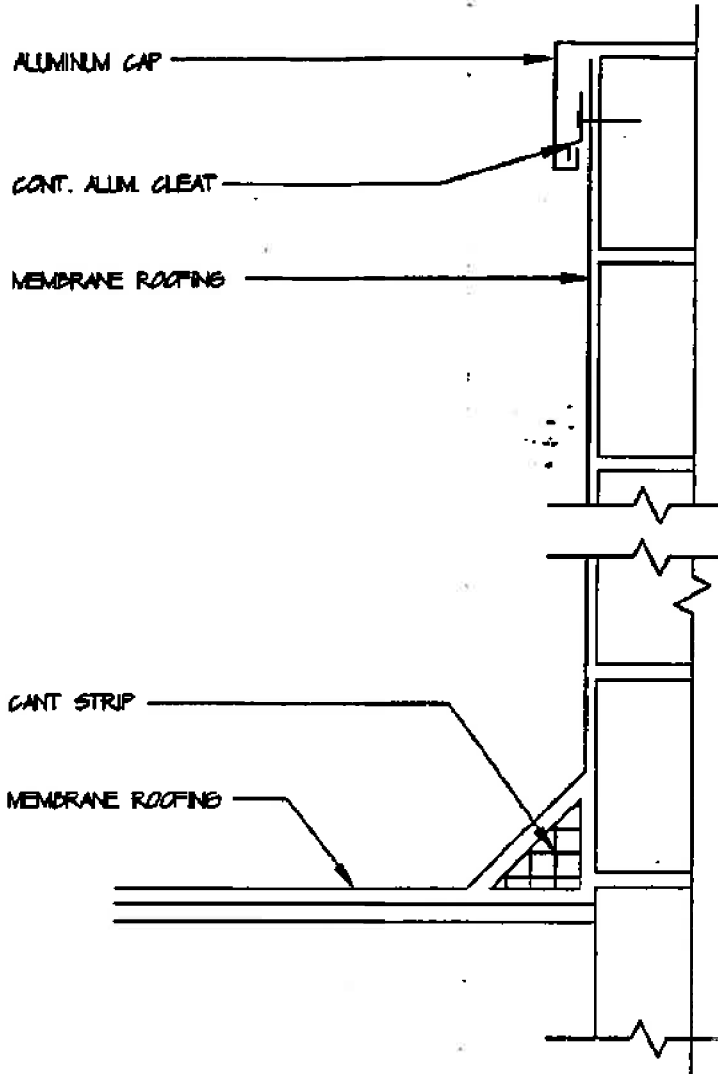
DATE	PROJECT & SHEET TITLES	DESCRIPTION	FIGURE
AUG 1997	OSAGE/PINE STREET INSPECTIONS ROOF REPAIRS	PARAPET FLASHING/CAPPING DETAIL	2
ARCHITECT SJM			
SCALE 1/2" = 1'-0"

3.1.4. The torch applied, single membrane roofing system which exists on all properties has undergone several local repairs over the years due to problems related to its original installation. There are many locations where the joints between sheets have opened and where the substrate has deteriorated. The parapet walls and roof penetrations are improperly flashed. Parapet gutter boxes should be replaced and properly sealed. Replacement of the existing roofing system with a similar type roofing system is recommended (Repair Item 4). Proper joining of sheets and proper flashing are critical to prevent recurring problems. It is anticipated that approximately 15% of roof sheathing has deteriorated to the point of requiring replacement. Special attention should be paid to the parapet flashing. Flashing should be provided as per Figure 2.

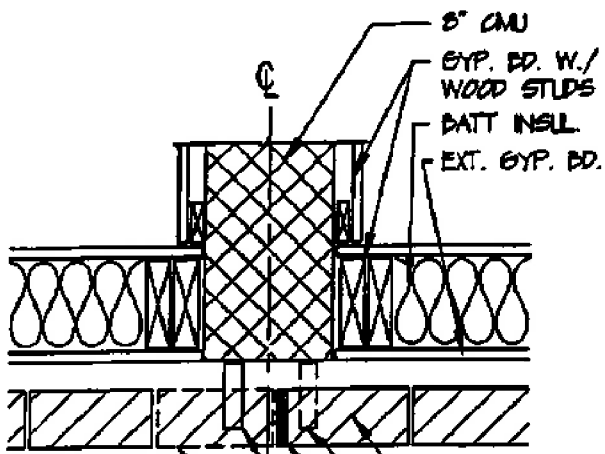
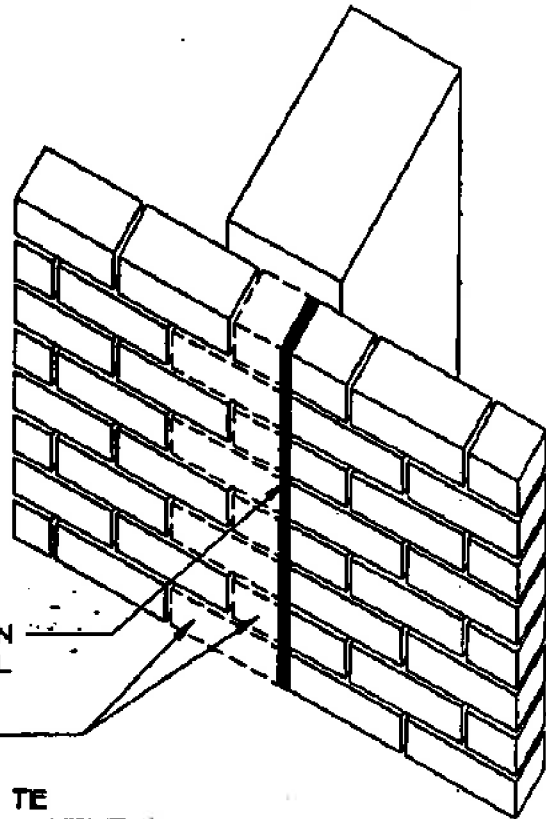
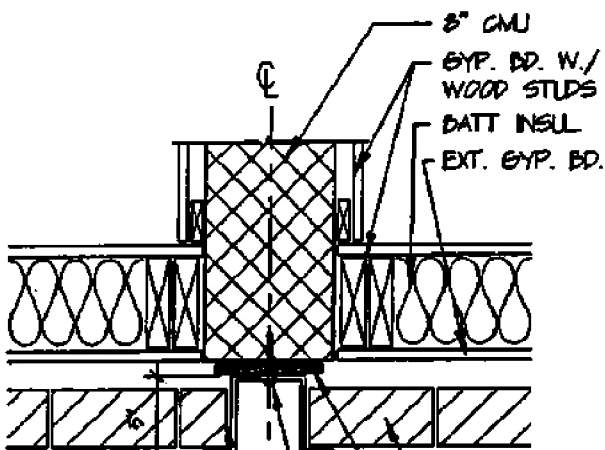
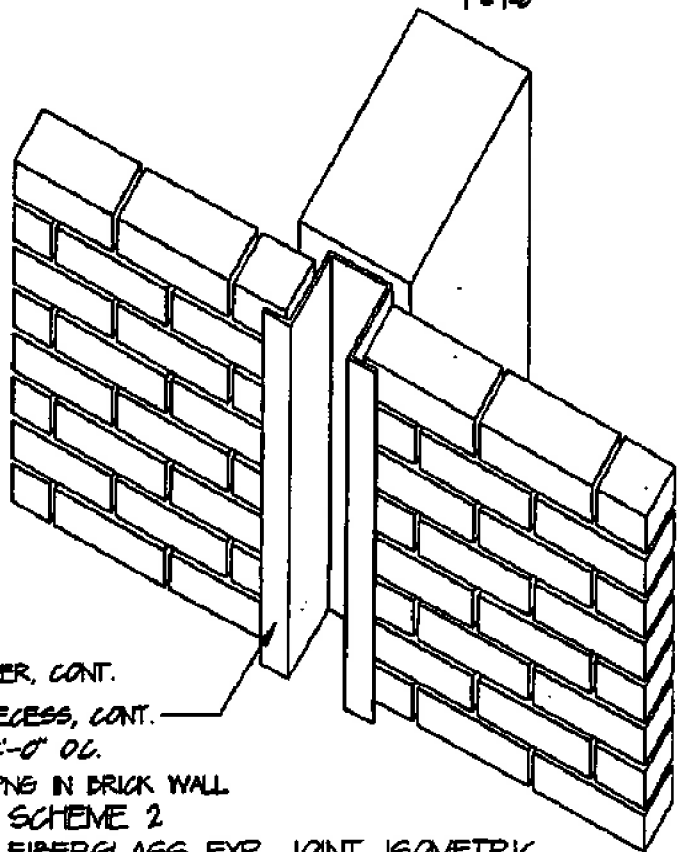
NO.	DATE	PROJECT & SHEET TITLES	DESCRIPTION	FIGURE
1	AUG 1987	OSAGE/PINE STREET INSPECTIONS EXPANSION JOINT DETAIL	NORTH SIDE OSAGE AVENUE REAR ELEVATIONS	3
DESIGNED BY	GW			
SCALE	1 = 1/8"

3.1.7. Brick cracking was observed on the alley (back) side of the odd numbered properties on Osage Avenue. Crack dimensions range from hairline to over ½". The cracks mainly run in a diagonal pattern through the mortar joints although some cracking through brick is apparent. Cracking is attributable to the lack of expansion joints in the brick veneer. Expansion joints, which were not provided for in the design documents, are recommended at rear party walls of each affected property. Joints should be constructed as detailed in Figure 3 (Repair Item 5) to prevent advancement of this condition. Areas where cracking has occurred should be repaired as indicated in Figure 4 (Repair Item 6). There are a few instances of spalling/missing brick at the pilasters between the garage doors and man doors. These areas should be repaired in a similar manner.

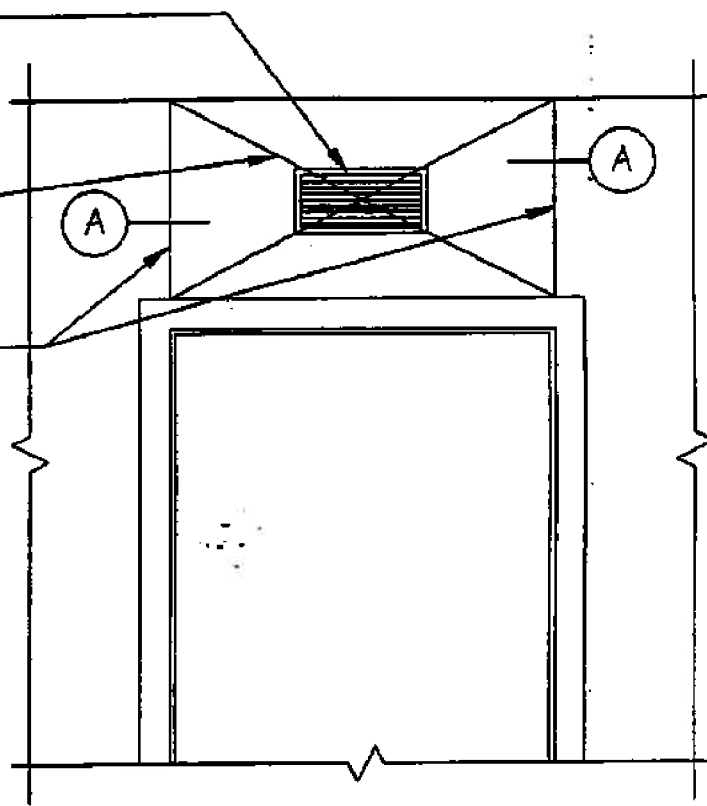
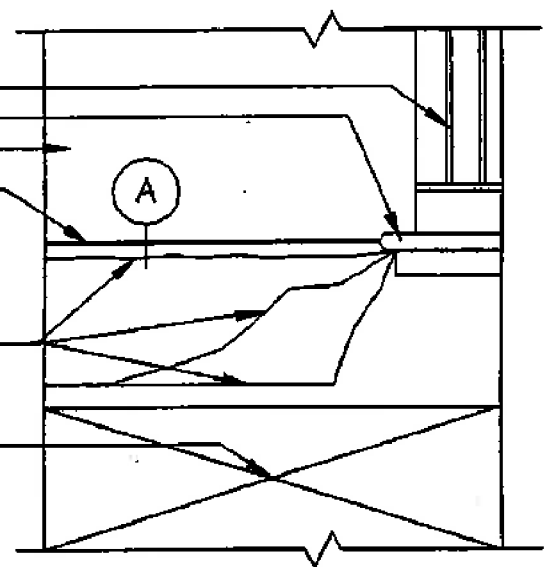
DATE	PROJECT & SHEET TITLES	DESCRIPTION	FIGURE
AUG 1997	OSAGE/PINE STREET INSPECTIONS WALL CRACKING	GYPSUM BOARD CONTROL JOINT	6
ARCHITECT: GJW			
SCALE: NTS.

- **Diagonal cracking typically occurred at transfer registers located over the bedroom doorways of south side Pine Street and north side Osage Avenue properties. One possible solution is to simply spackle, sand and paint at all locations. This repair is likely to be temporary; however, and reflective cracking is likely. A more permanent, although more costly solution (presented in Appendix G), would be to replace the section of drywall over the doorway and add control joints on either side (Repair Item 20) (Figure 6).**

- **Another recurring crack location is at the stair header. This condition is also typical for properties on the south side of Pine Street and the north side of Osage Avenue. The different configuration at the stair header of properties on the south side of Osage Avenue may explain the absence of this finding. While it is possible that this situation is related to findings presented in paragraph 3.2.3., it is more likely the result of normal drying and dimensional changes of construction materials. Cracking appears to be purely cosmetic and does not present a cause for concern other than of an aesthetic nature. Recommended constructing control joint as indicated in Figure 6 (Repair Item 21).**

REMOVE GYPSUM BOARD  
AND REPLACE WITH NEW

PROVIDE GALV. STEEL CONTROL  
JOINT, BOTH SIDES OF DOOR  
AND BOTH SIDES OF WALL
