**US Army Corps  
of Engineers  
Philadelphia District**

## **Osage Avenue/Pine Street Inspections**

### **Final Report of Findings and Recommendations**

December 1997

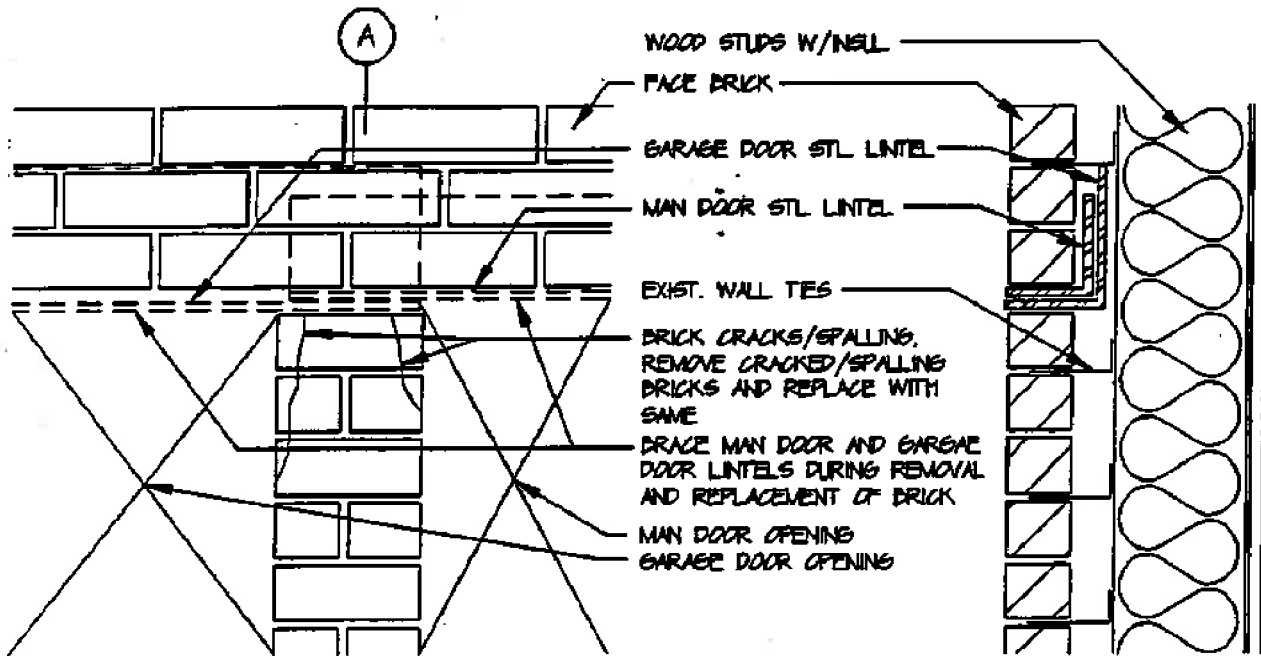
DATE	PROJECT & SHEET TITLES	DESCRIPTION	FIGURE
AUG 1997	OSAGE/PINE STREET INSPECTIONS BRICK REPAIR DETAILS	NORTH SIDE OSAGE AVENUE REAR ELEVATIONS	4
SCALE			
1/2" = 1'-0"

- WOOD STUDS W/NEEL
- FACE BRICK
- GARAGE DOOR STL LINTEL
- MAN DOOR STL LINTEL
- EXIST. WALL TIES
- BRICK CRACKS/SPALLING, REMOVE CRACKED/SPALLING BRICKS AND REPLACE WITH SAME
- BRACE MAN DOOR AND GARAGE DOOR LINTELS DURING REMOVAL AND REPLACEMENT OF BRICK
- MAN DOOR OPENING
- GARAGE DOOR OPENING

NOTE:  
 WOOD DOOR FRAMES NOT SHOWN FOR CLARITY.  
 WOOD DOOR JAMB/HEAD SHALL BE REMOVED  
 FOR INSTALLATION OF NEW BRICK WOOD JAMB/  
 HEAD SHALL BE REINSTALLED, SEALED, AND PAINTED.
