HAWTHORNE CULTURAL CENTER - CARPENTER & 12TH STREET

HAWTHORNE CULTURAL CENTER PHOTO DOCUMENTATION

Project Information		Groundwater Readings		Excavation Information	
Project Name:	Hawthorne Cultural Center	Time	@ completion	Contractor: Ramos & Associates	
Project Number:	14-0204134	Depth	Dry	Operator: Kevin	
Location:	1200 Carpenter St.	Ground Surface Elevation:		Make:	Case Model: 590
Municipality:	City of Philadelphia			Capacity:	N.A. Reach:>10'
County, State:	Philadelphia County, PA

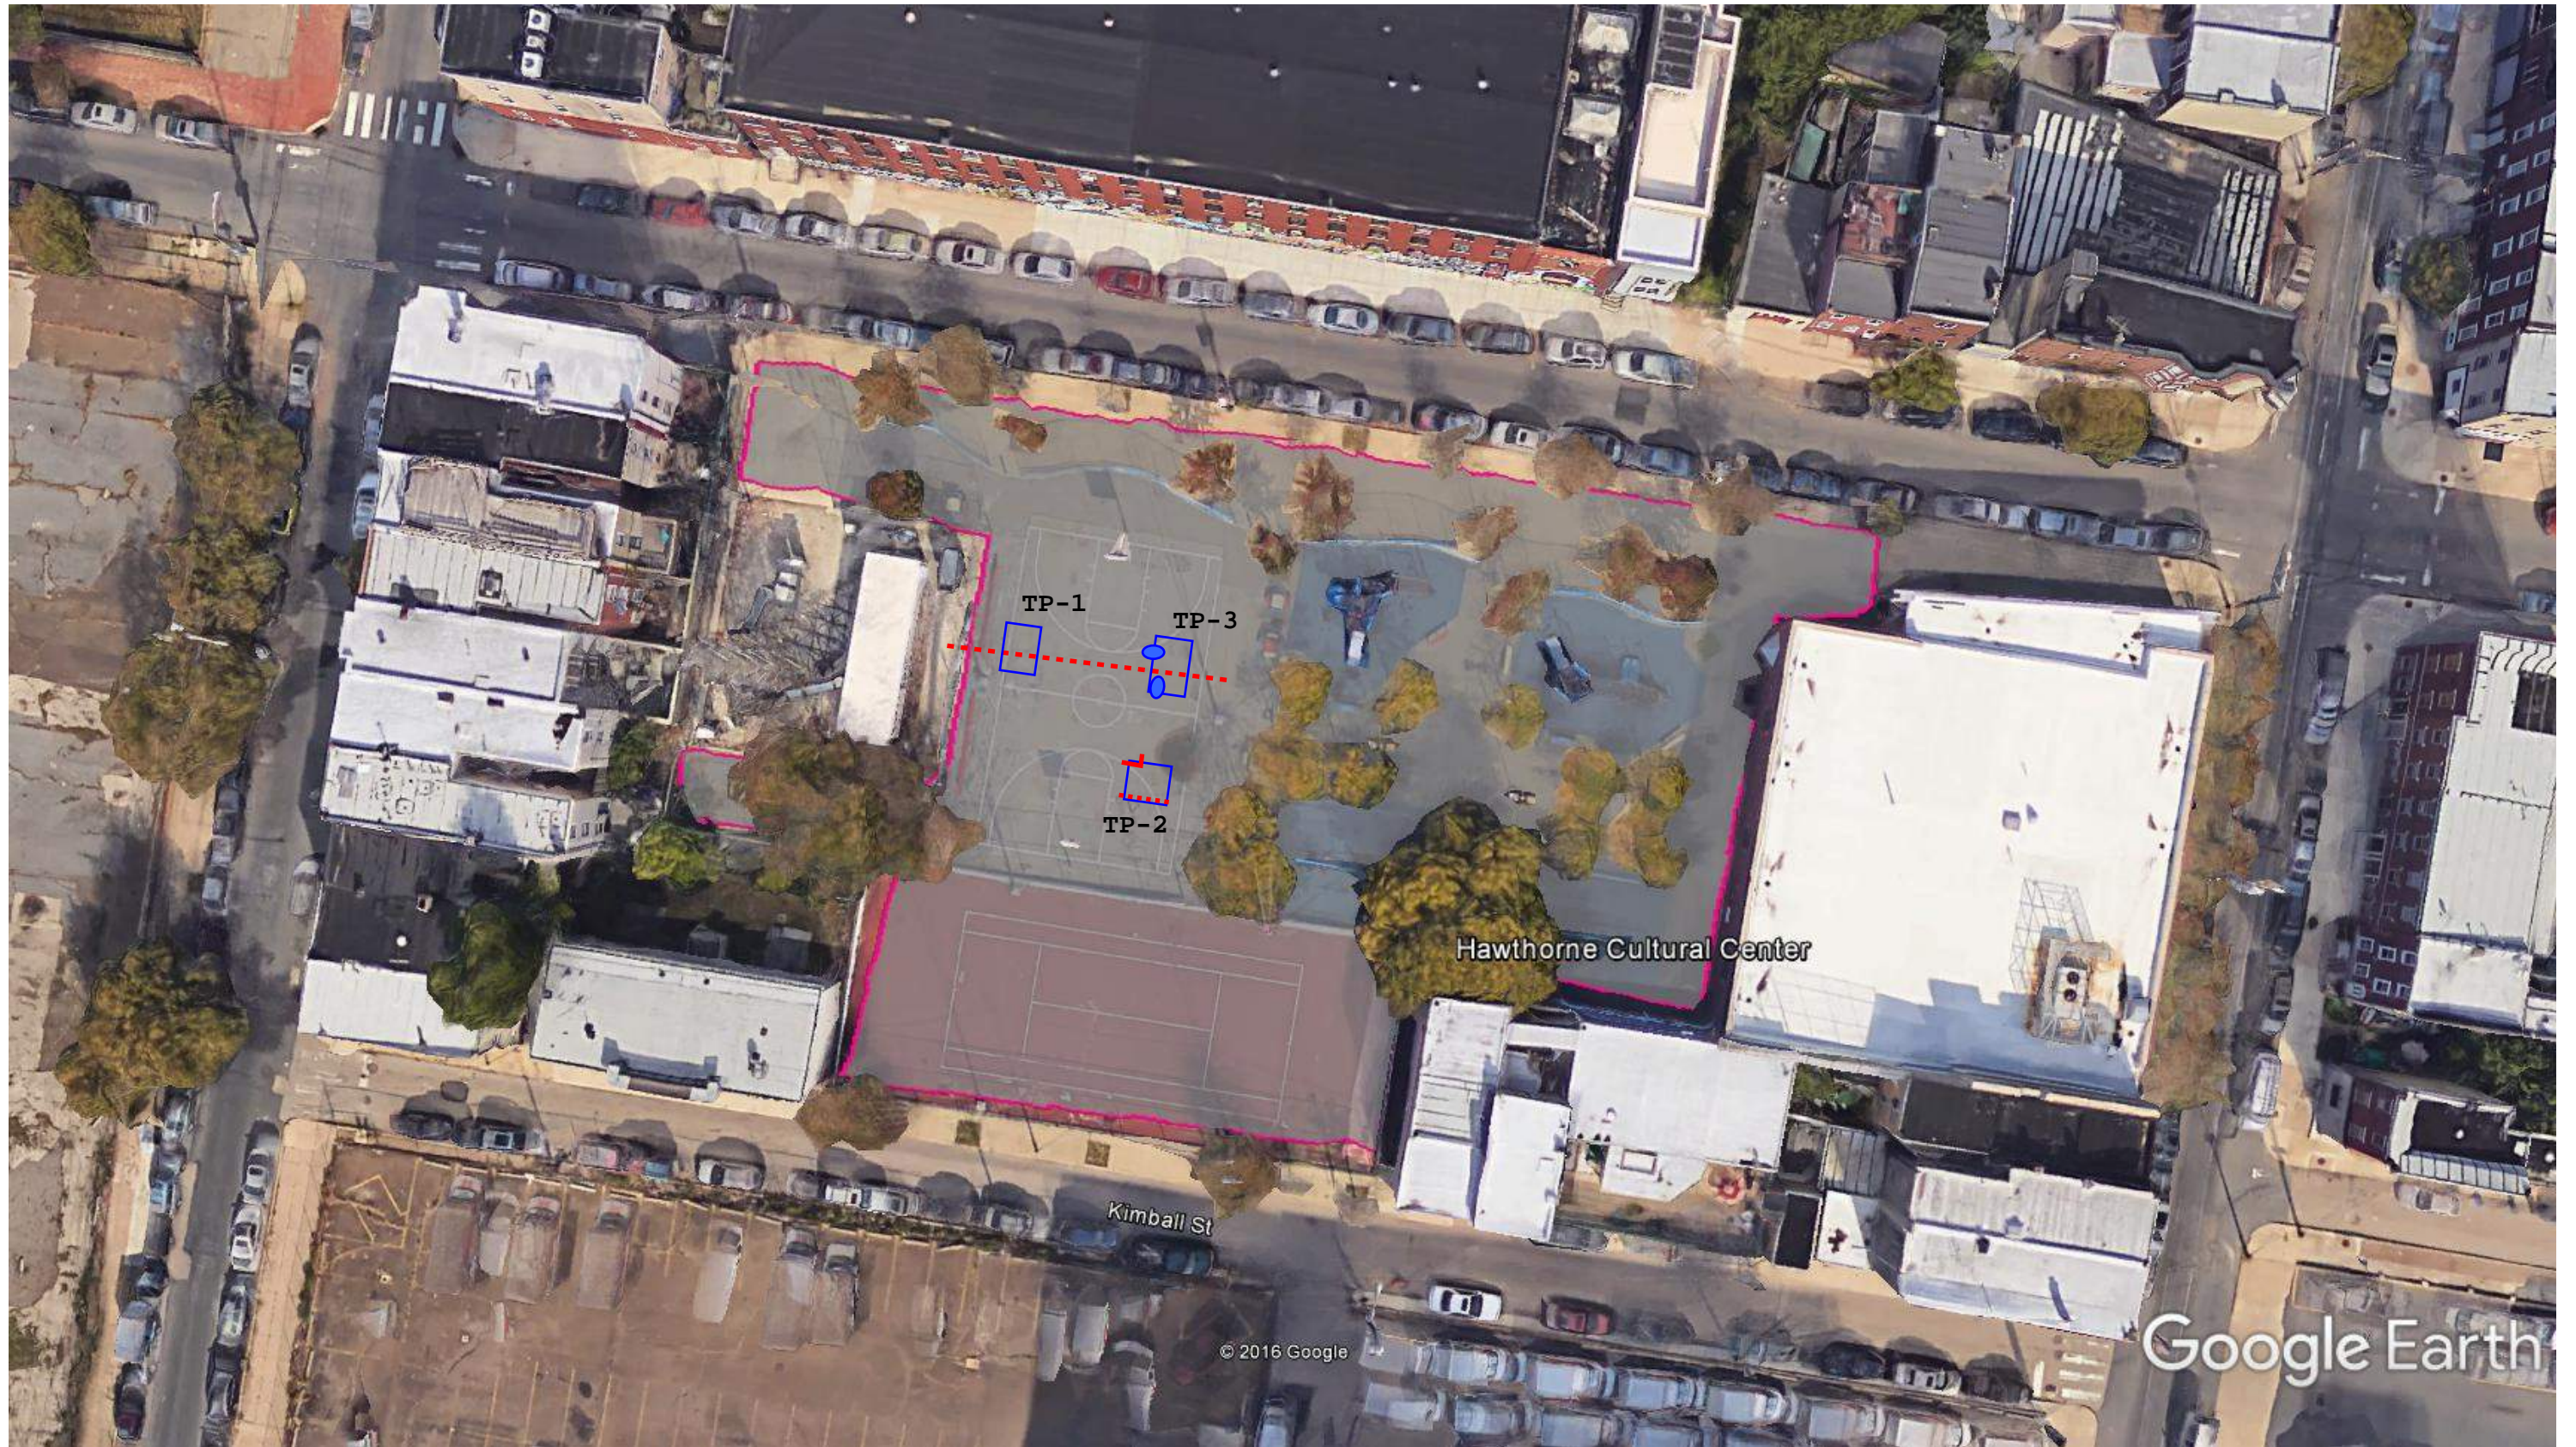
TEST PIT LOCATION SKETCH
NOT TO SCALE

PROPOSED GEOPHYSICAL SURVEY AREA
- NOTE - LOCATIONS APPROXIMATE

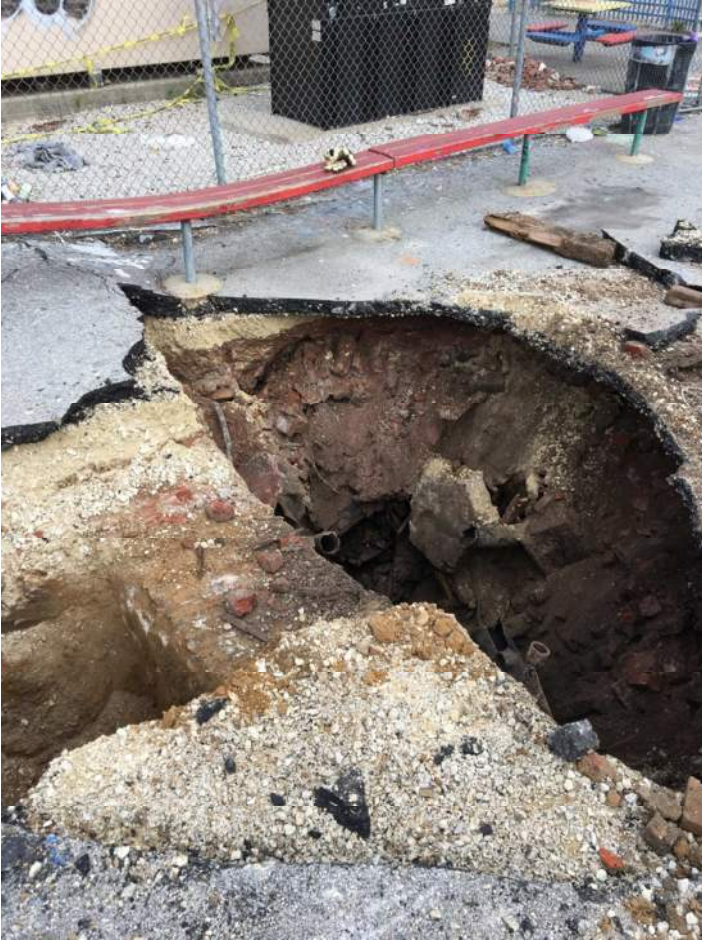
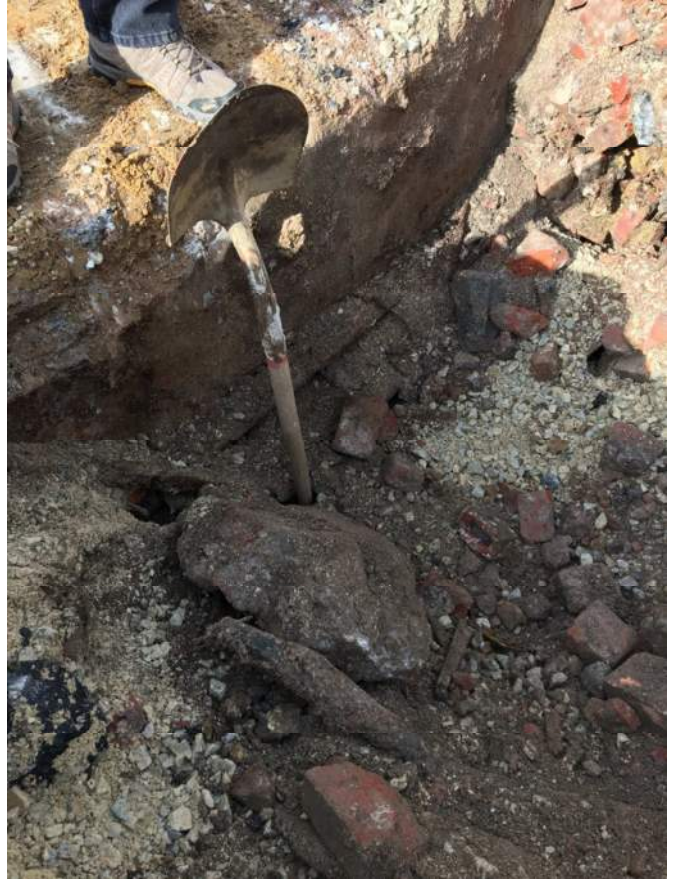
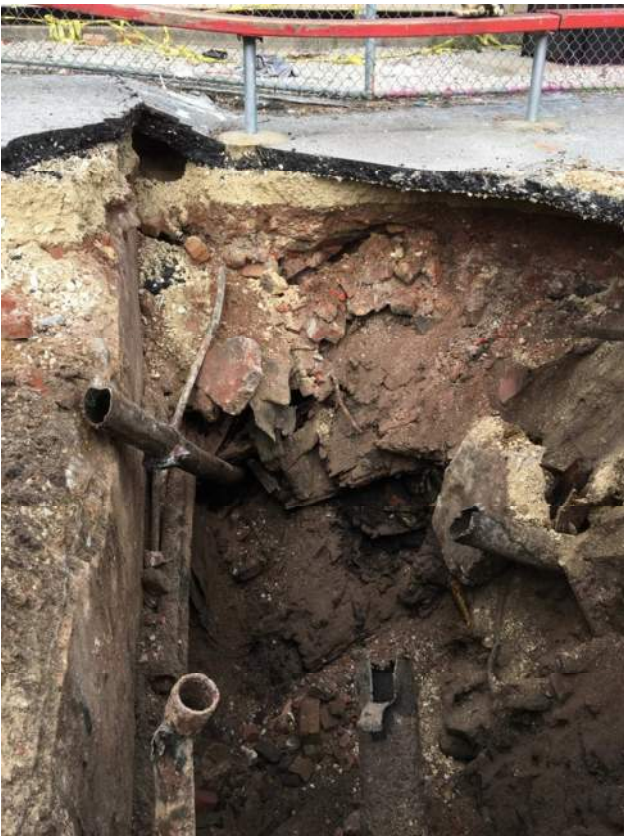
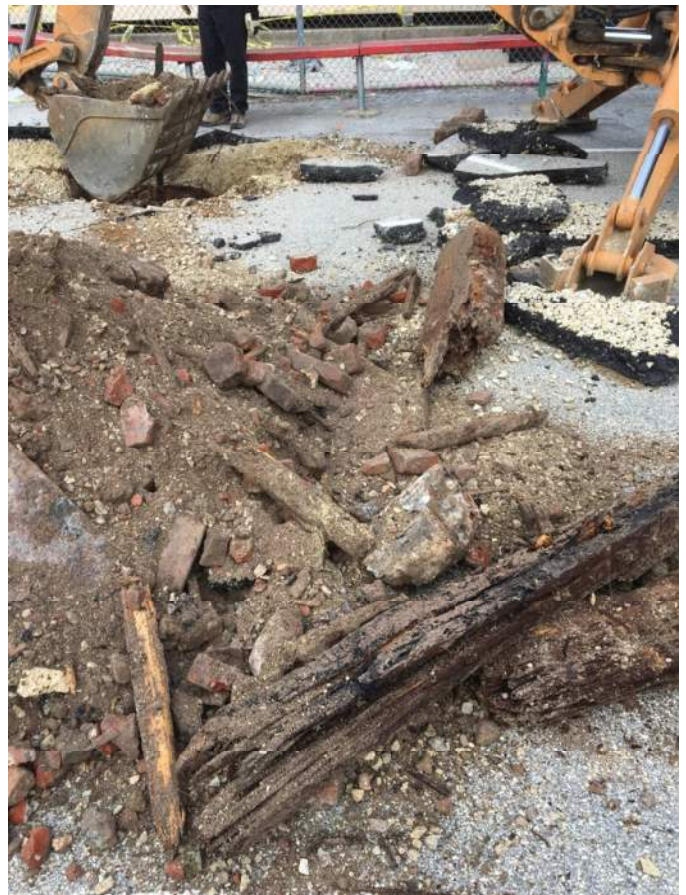
Test Pit #1, April 19, 2017

DEPTH (ft)	ELEV.	DESCRIPTION	GROUND WATER NOTES	EXCAV. EFFORT	REMARKS / SAMPLES	
0		ASPHALT	0.42'			
		STONE	0.50'	DRY	M	
1		FILL				
2		Very loose construction debris: timber, brick and concrete rubble, metal pipe, miscellaneous debris, some voids along concrete wall		DRY	M	Concrete wall encountered at 1.5'
3			DRY	M		
4			DRY	M		
5			DRY	M	Pipe and conduit encountered at 4.5'	
6			DRY	M		
7			DRY	M	*Basement on North Side of concrete wall, brown silty fill soil, trace brick, on South Side of wall	
8			DRY	M		
9			DRY	M		
9.50'				DRY	M	
10			Test Pit Terminated on Concrete Slab (Basement Floor)

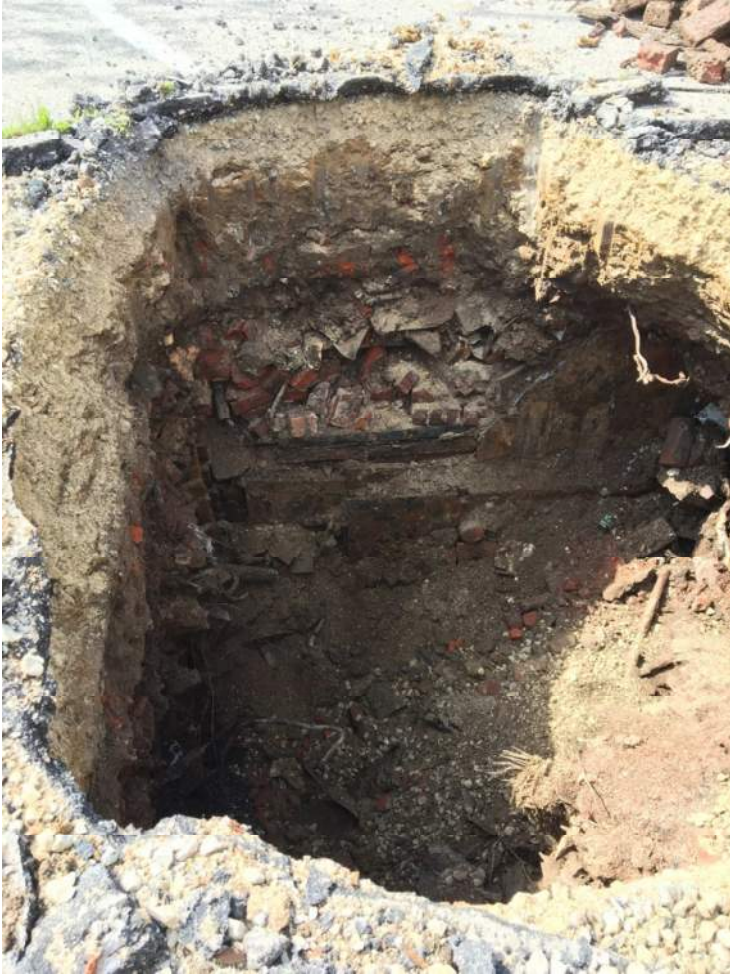
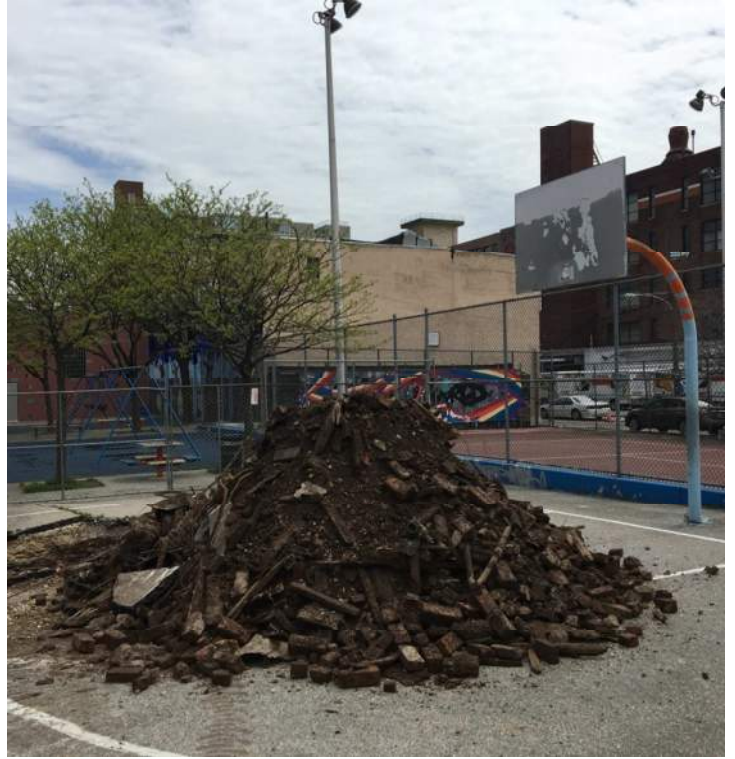
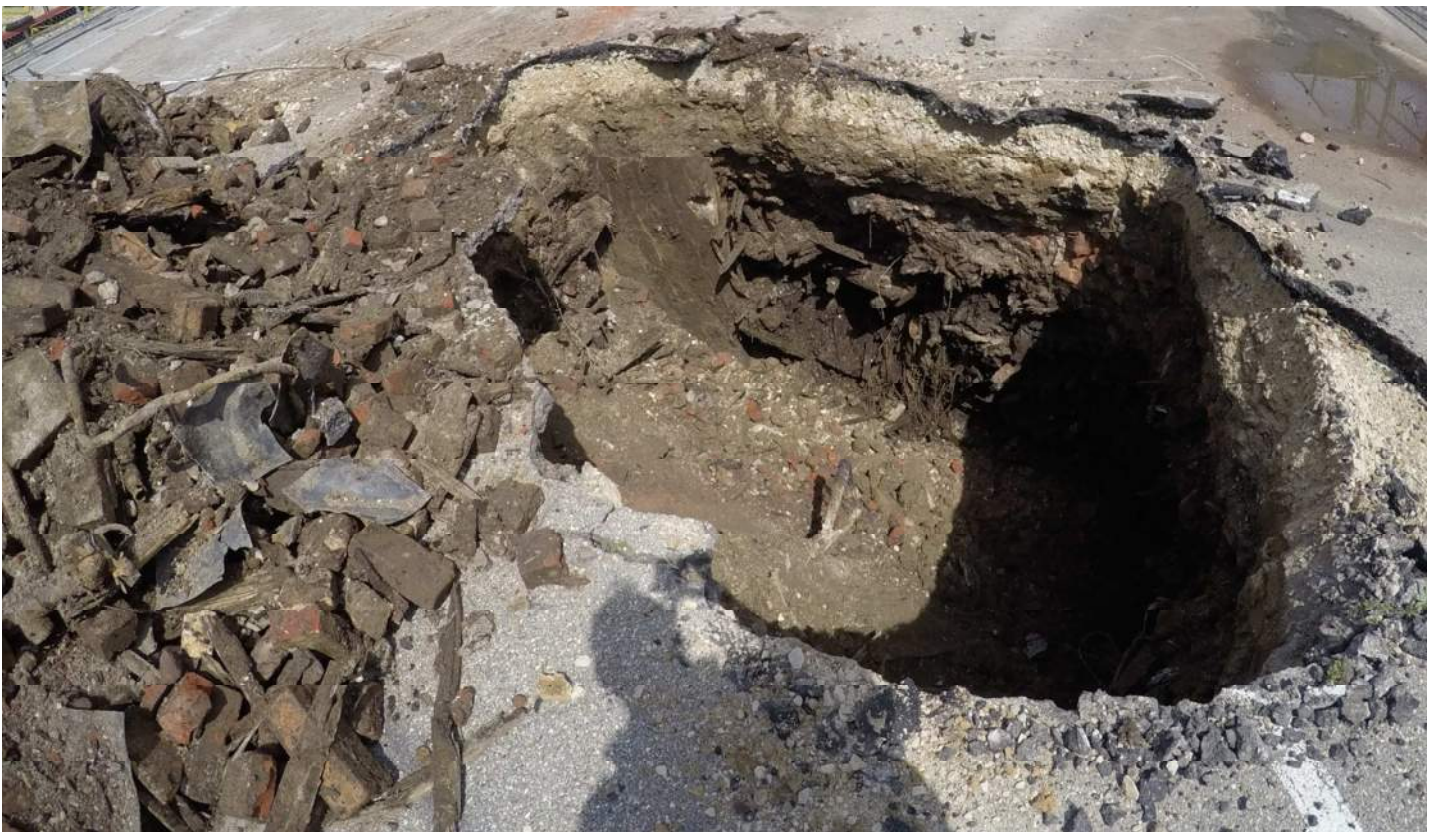
Test Pit #2, April 19, 2017

DEPTH (ft)	ELEV.	DESCRIPTION	GROUND WATER NOTES	EXCAV. EFFORT	REMARKS / SAMPLES
0		ASPHALT	0.33		
		STONE	0.67'	DRY	M
1		FILL			
		FILL SOIL: Medium dense silty SAND, some brick	2.00'	DRY	M
2		FILL SOIL: Loose silty SAND and BRICK		DRY	M
3			4.00'	DRY	M
4		CONSTRUCTION DEBRIS: Very loose brick, organics (timber), pipe, concrete fragments		DRY	M
5				DRY	M
6				DRY	M
7				DRY	M
8				DRY	M
9			9.00'	DRY	M
10		TP Terminated on Concrete Slab (Basement Floor)

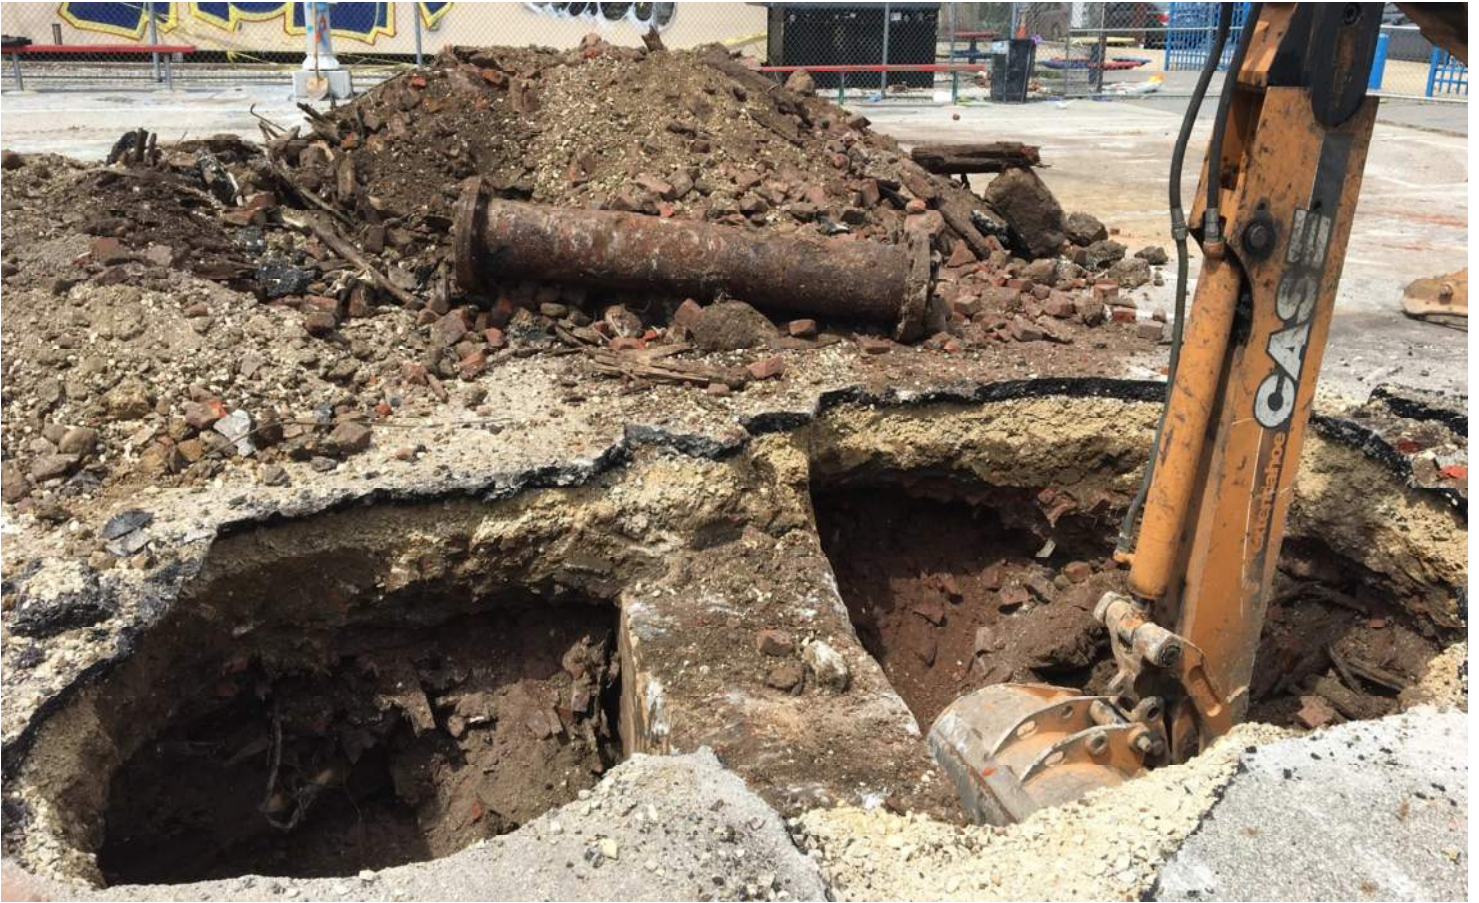
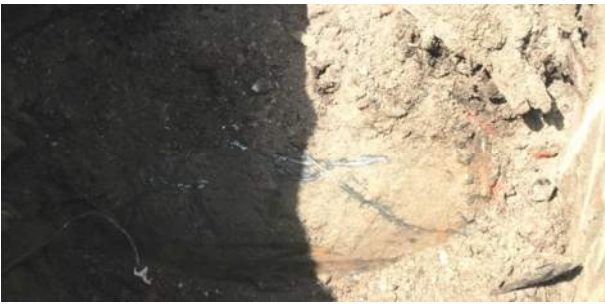
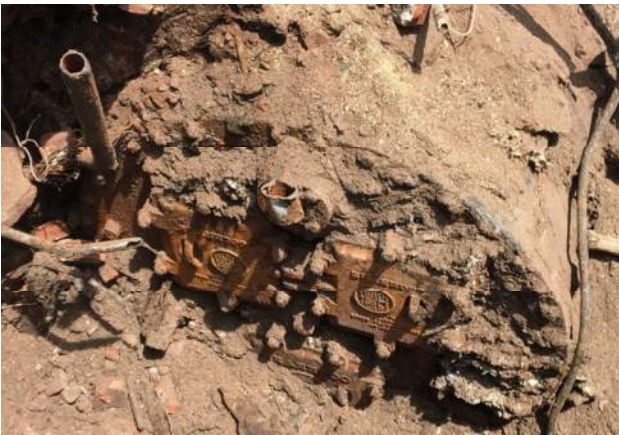
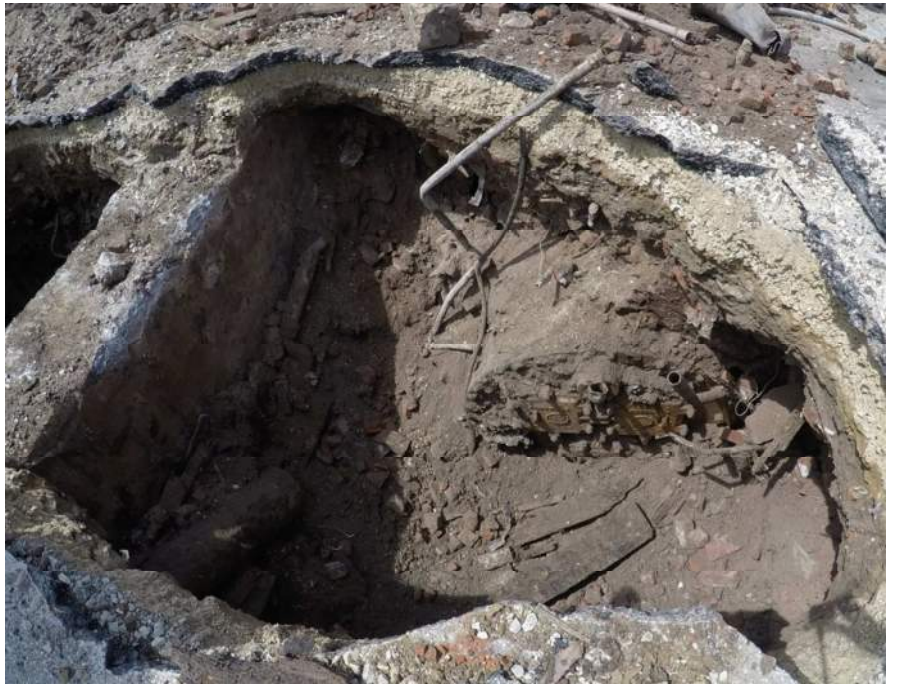
Test Pit #3, April 19, 2017

DEPTH (ft)	ELEV.	DESCRIPTION	GROUND WATER NOTES	EXCAV. EFFORT	REMARKS / SAMPLES
0		ASPHALT	0.33'		
		STONE	0.83'	DRY	M
1		FILL			
		CONSTRUCTION DEBRIS (North & South Side): Loose timber, brick, trace metal, voids		DRY	M
2		Concrete footing encountered at 1.5'		DRY	M
3				DRY	M
4				DRY	M
5				DRY	M
6				DRY	M
7				DRY	M
8			8.00'	DRY	M
9		Test Pit Terminated due to Boiler			
10
